PBY Catalina

Walk Around

By William Scarborough

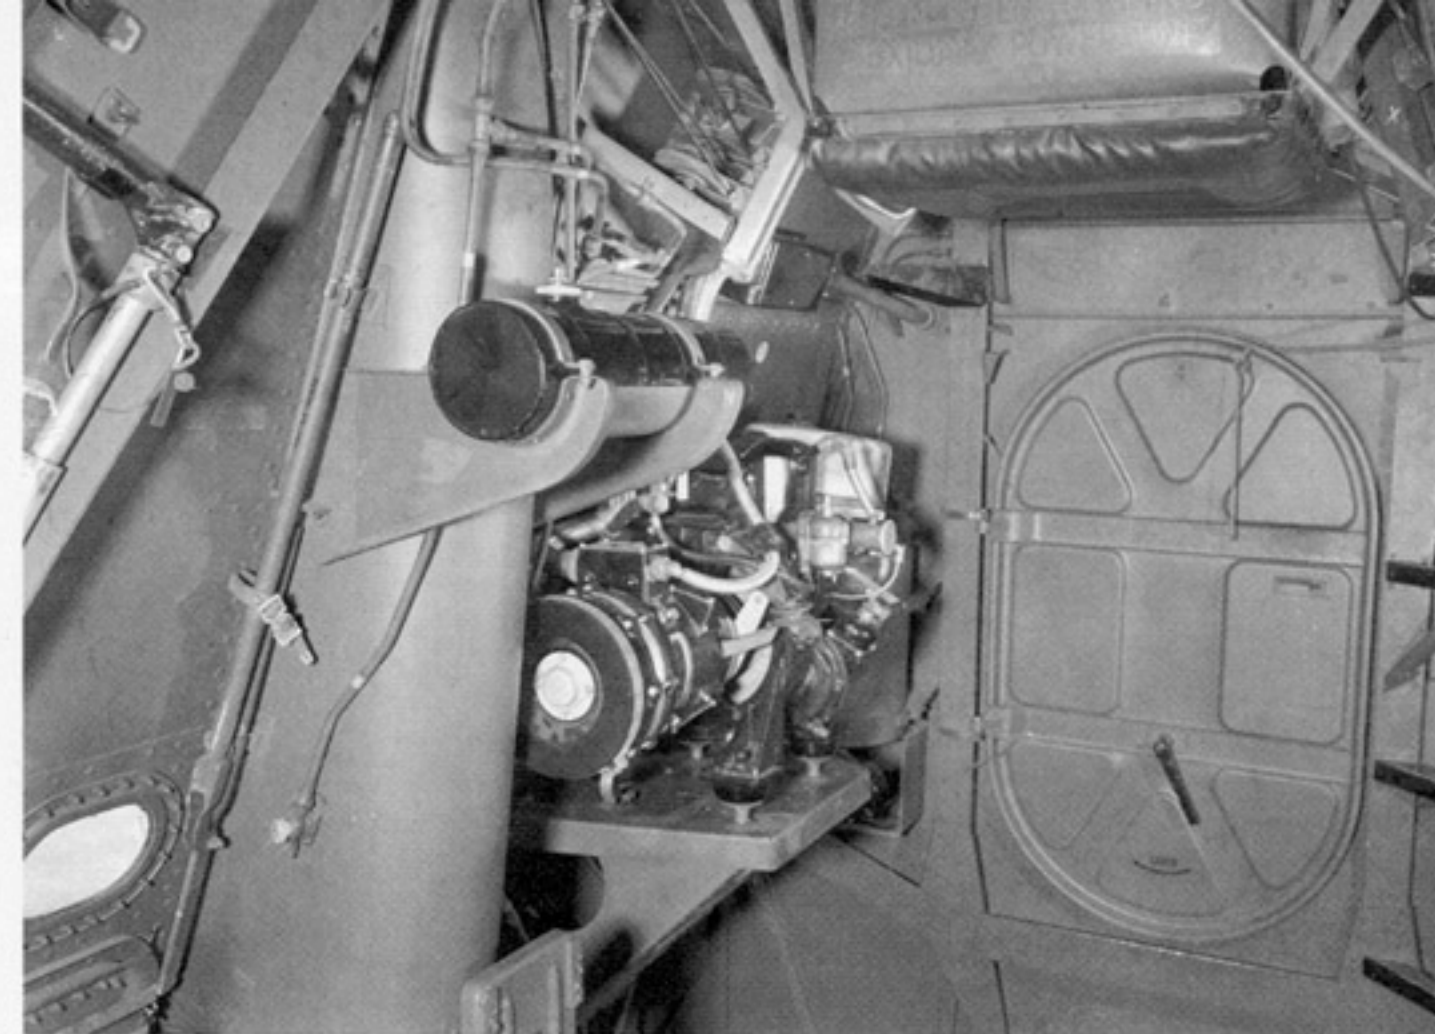
Left forward corner of the Mechanic's compartment: At left was the multi-purpose crank used for manual operation (if power failed) of the engine starter, anchor reel, and wing tip floats. The fuel tank for the auxiliary power unit (APU) was mounted above the APU. At the top is the bottom of Mechanic's seat, which was located within the wing support pylon and, at right, were the steps to the seat. (USN)

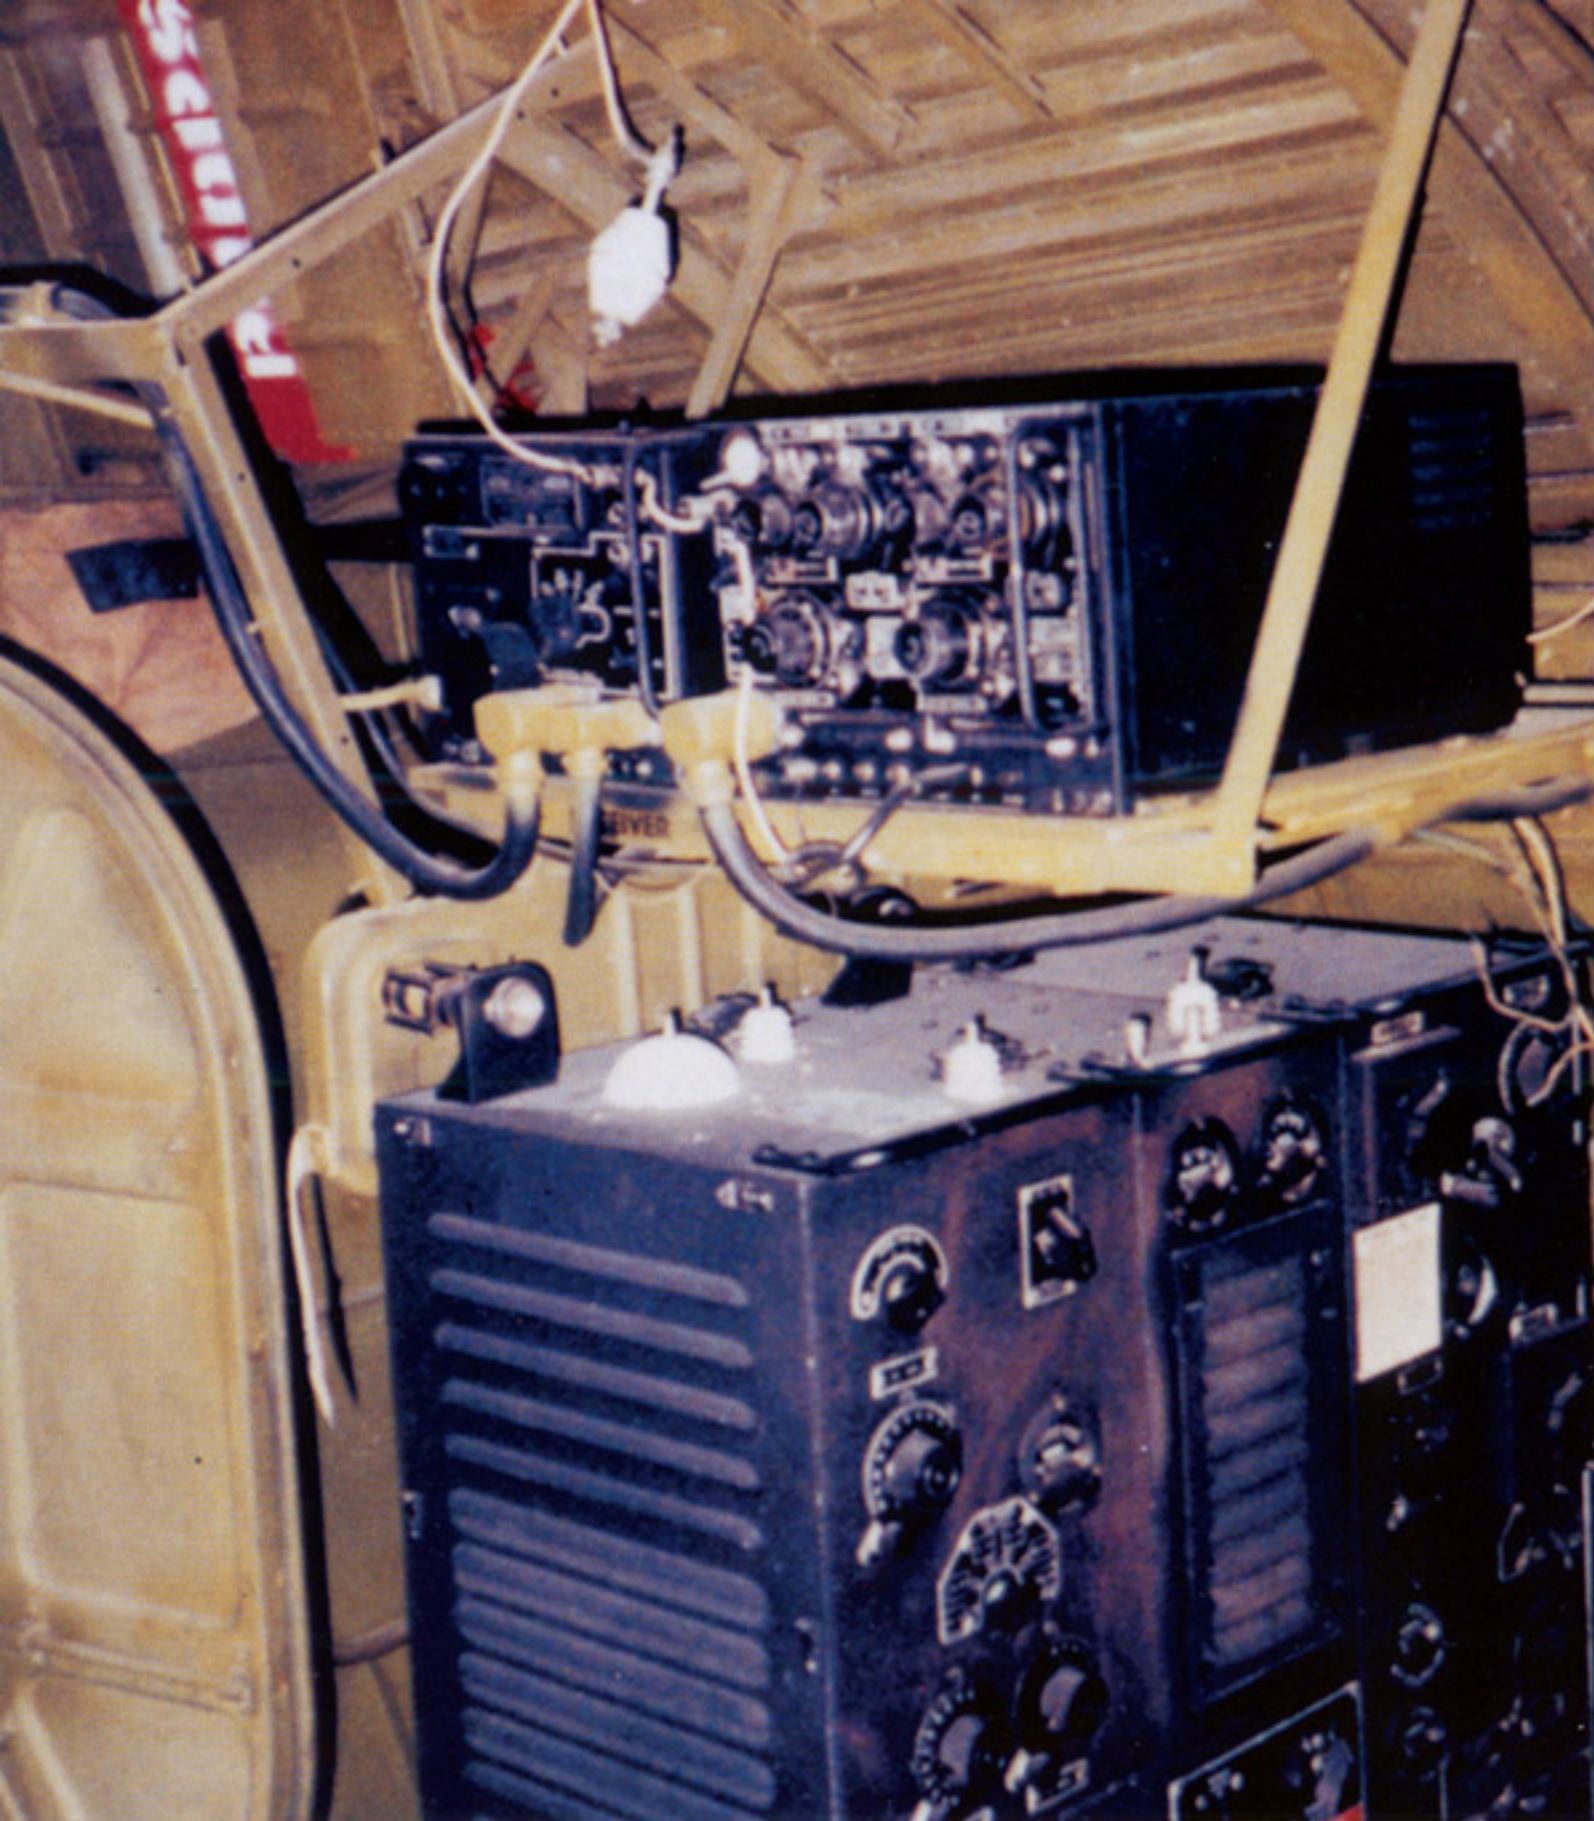
The starboard side of the Navigator/Radio compartment of the PBY-5 at the National Museum of Naval Aviation at Pensacola. From left: door to cockpit, the Black box next to the door is a long range GO-9 radio transmitter. The two boxes above the GO-9 are ARB (left).and ATB (right) Command Receiver & Transmitter. (Jim Mooney)

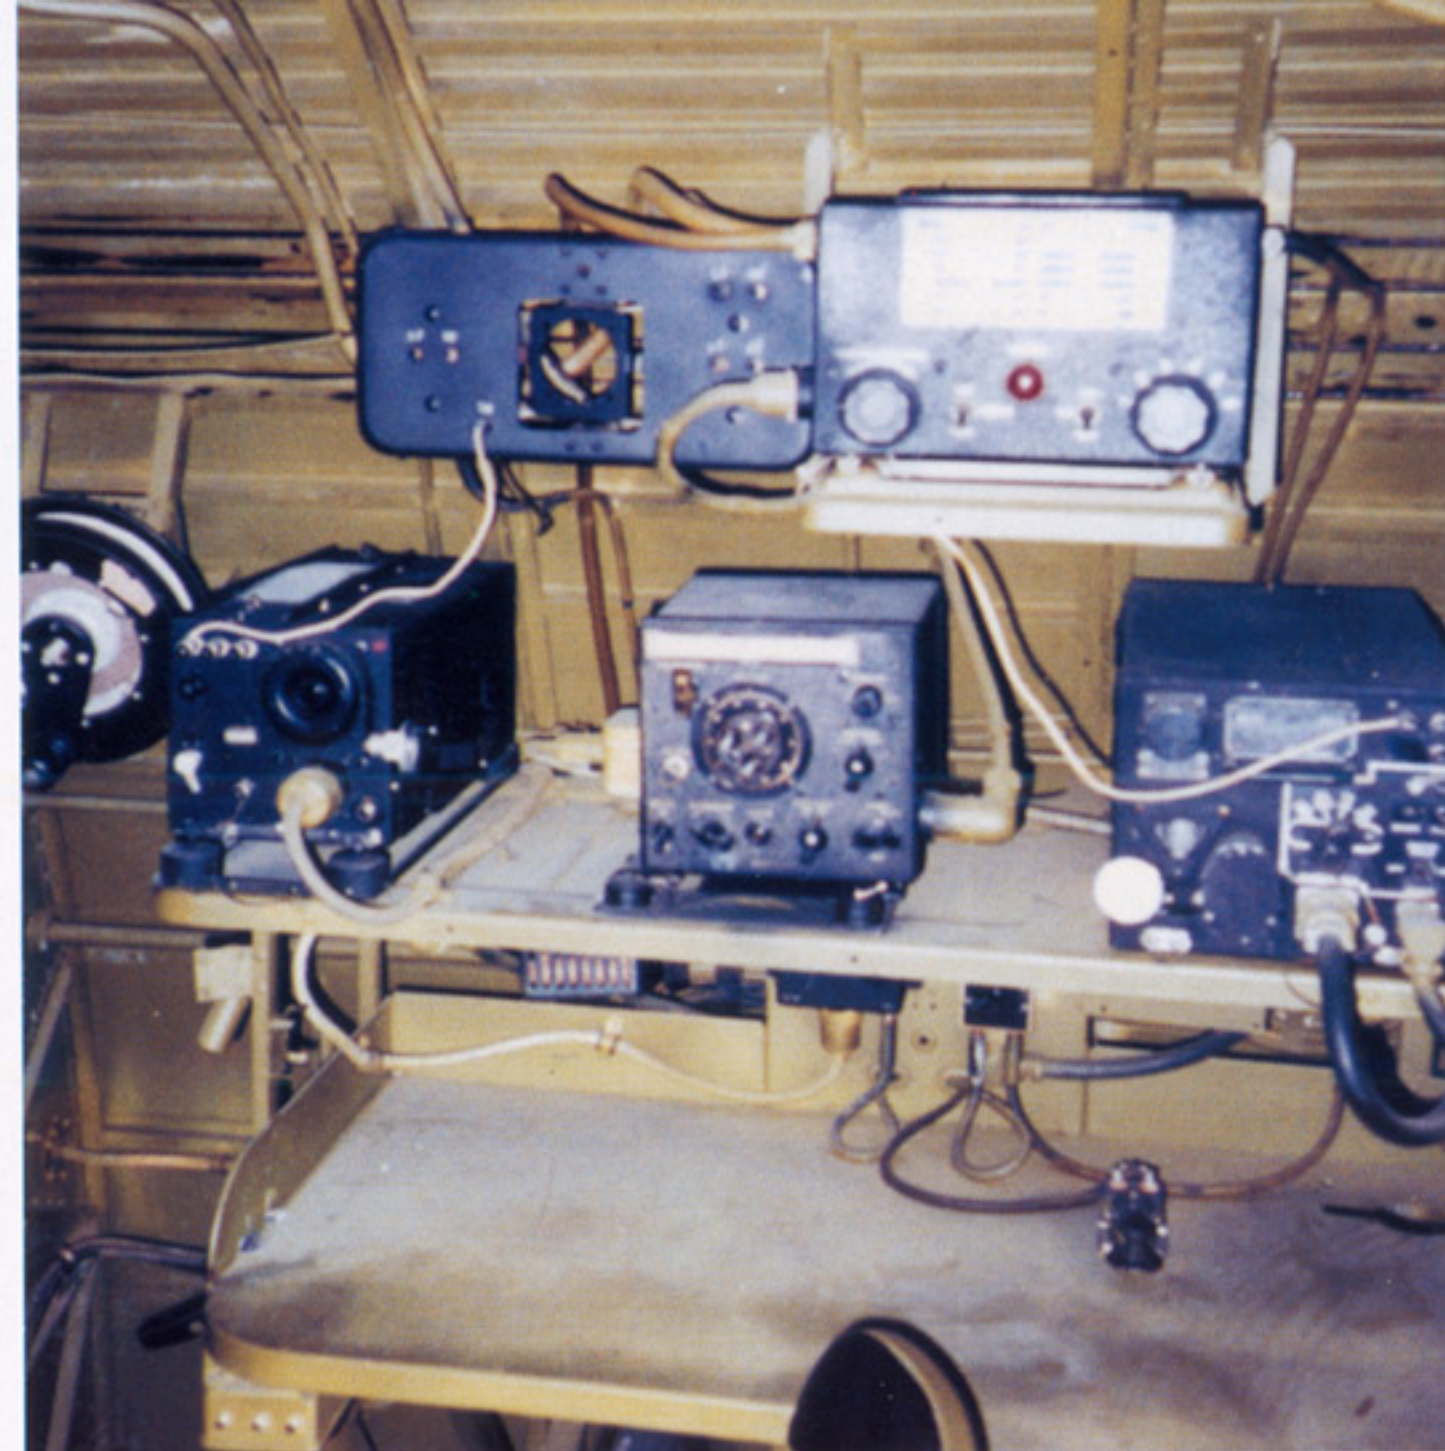
The reel with the handle is the trailing antenna. On the shelf above the desk is a RU-19 radio receiver, LM-10 frequency meter and Radio Operator's ARB unit. Above these are an antenna transfer and clock panel and ICS control. The radio operators sending key is on the desk. (Jim Mooney)

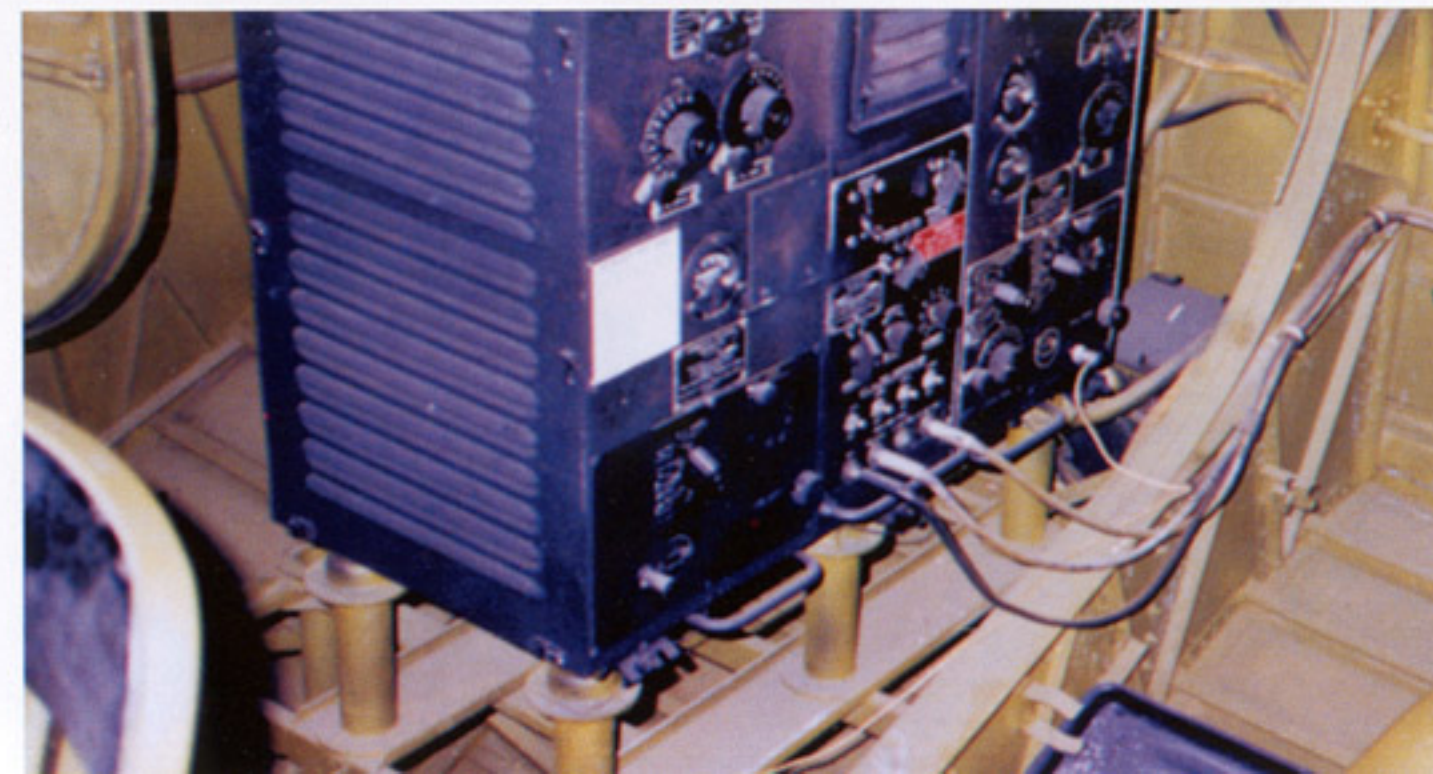
(Right) Located at the forward end of the compartment was the base of the long range GO-9 radio transmitter and its mounting posts. (Jim Mooney)

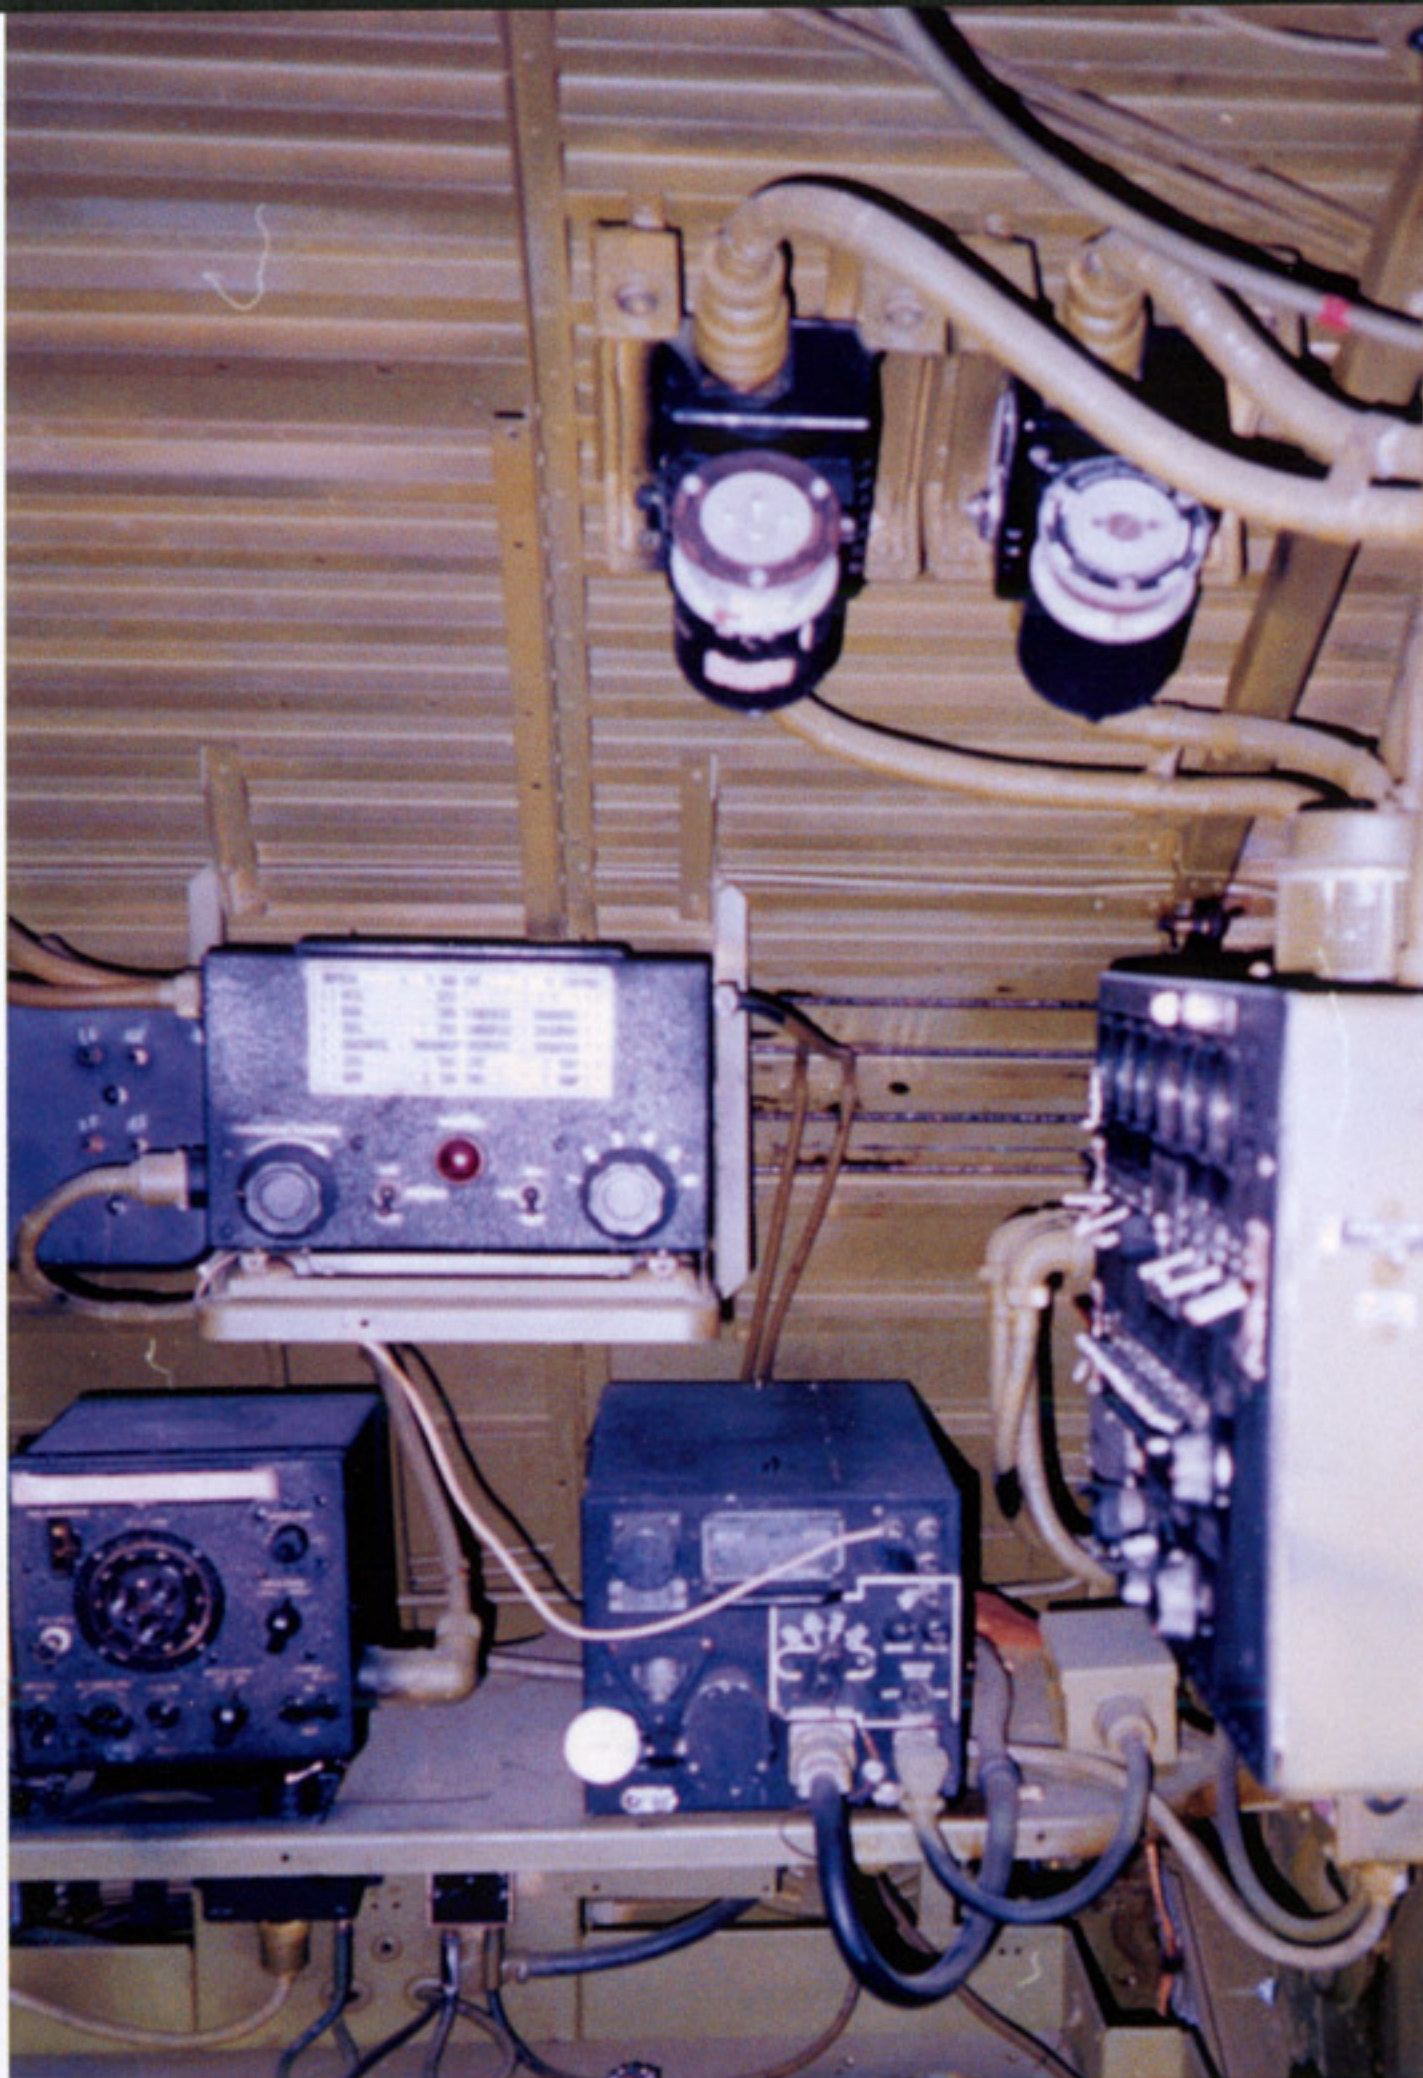
The right rear of the Navigation/Radio compartment of the PBY-5 at the National Museum of Naval Aviation at Pensacola. From forward end, on shelf above radio operator's desk: LM-10 frequency meter and ARB receiver. On a shelf above the LM-10 and ARB is the ISC control. On bulkhead, main power distribution panel. At top two engine generator voltage regulators. (Jim Mooney)

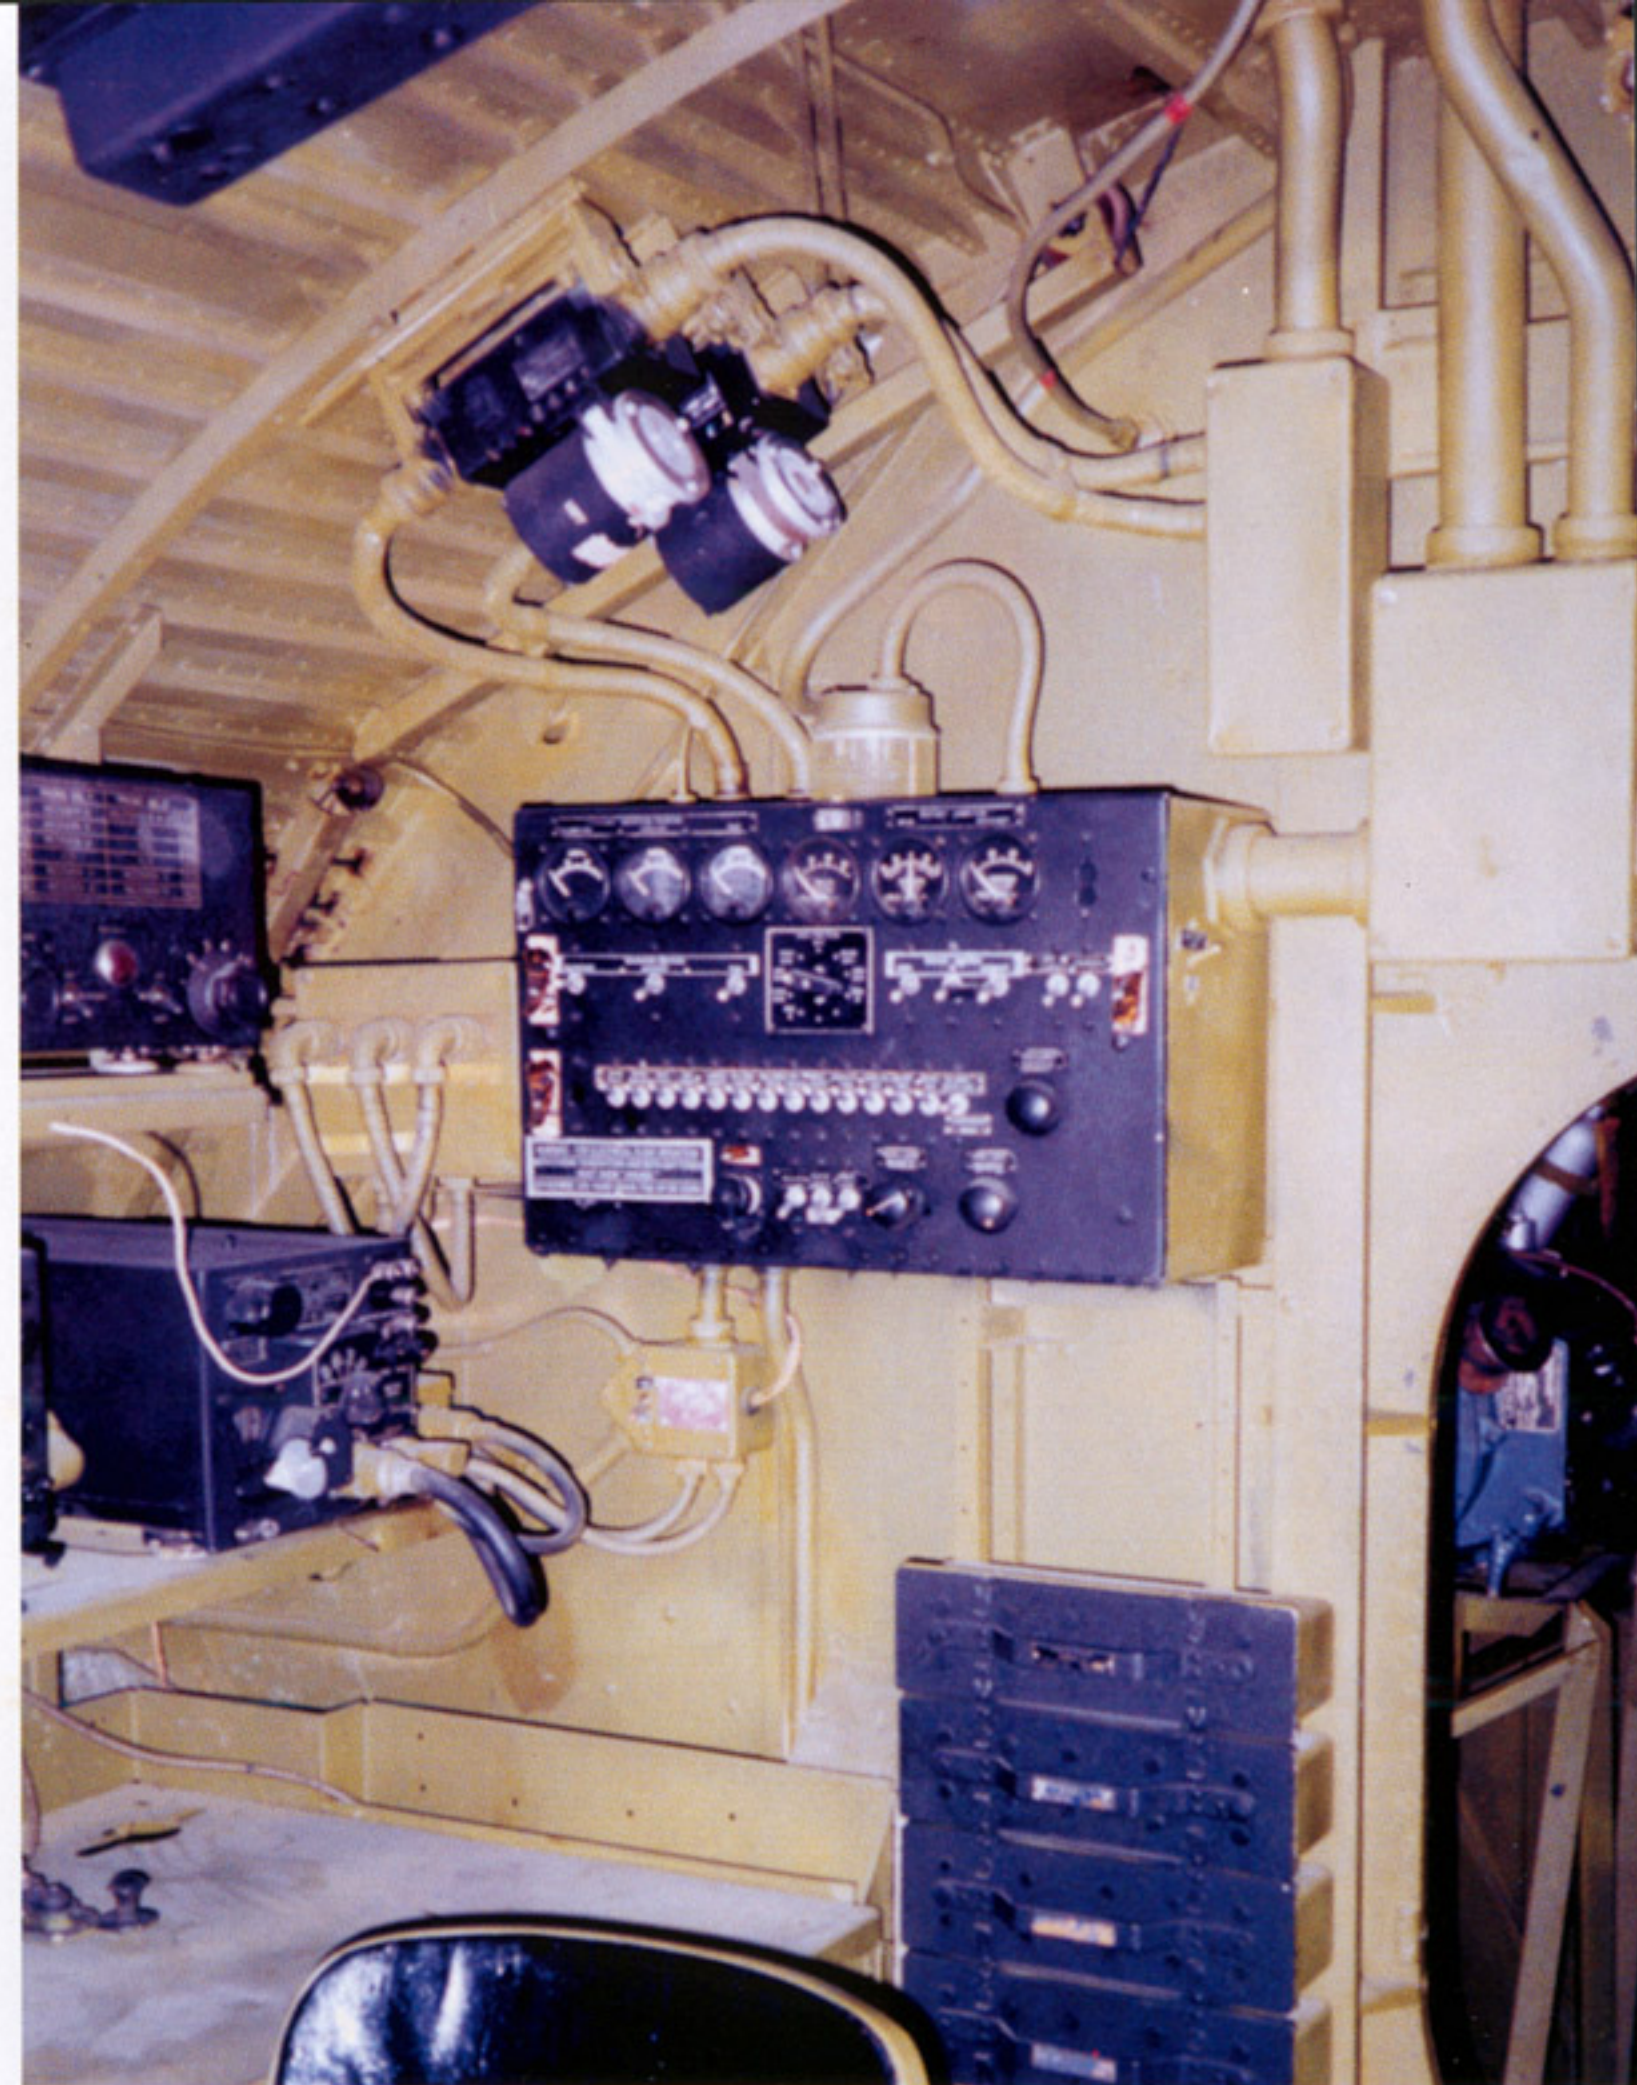
The rear bulkhead of the Navigator/Radio compartment. From lower left: Radioman's chair, Radio Key on desk, ARB Receiver, Antenna Transfer and Clock Panel, Engine Generator Voltage Regulators. On the aft bulkhead, Main Power Distribution Panel, below it are two coils for changing frequencies. The door is to the flight engineer's compartment. (Jim Mooney)

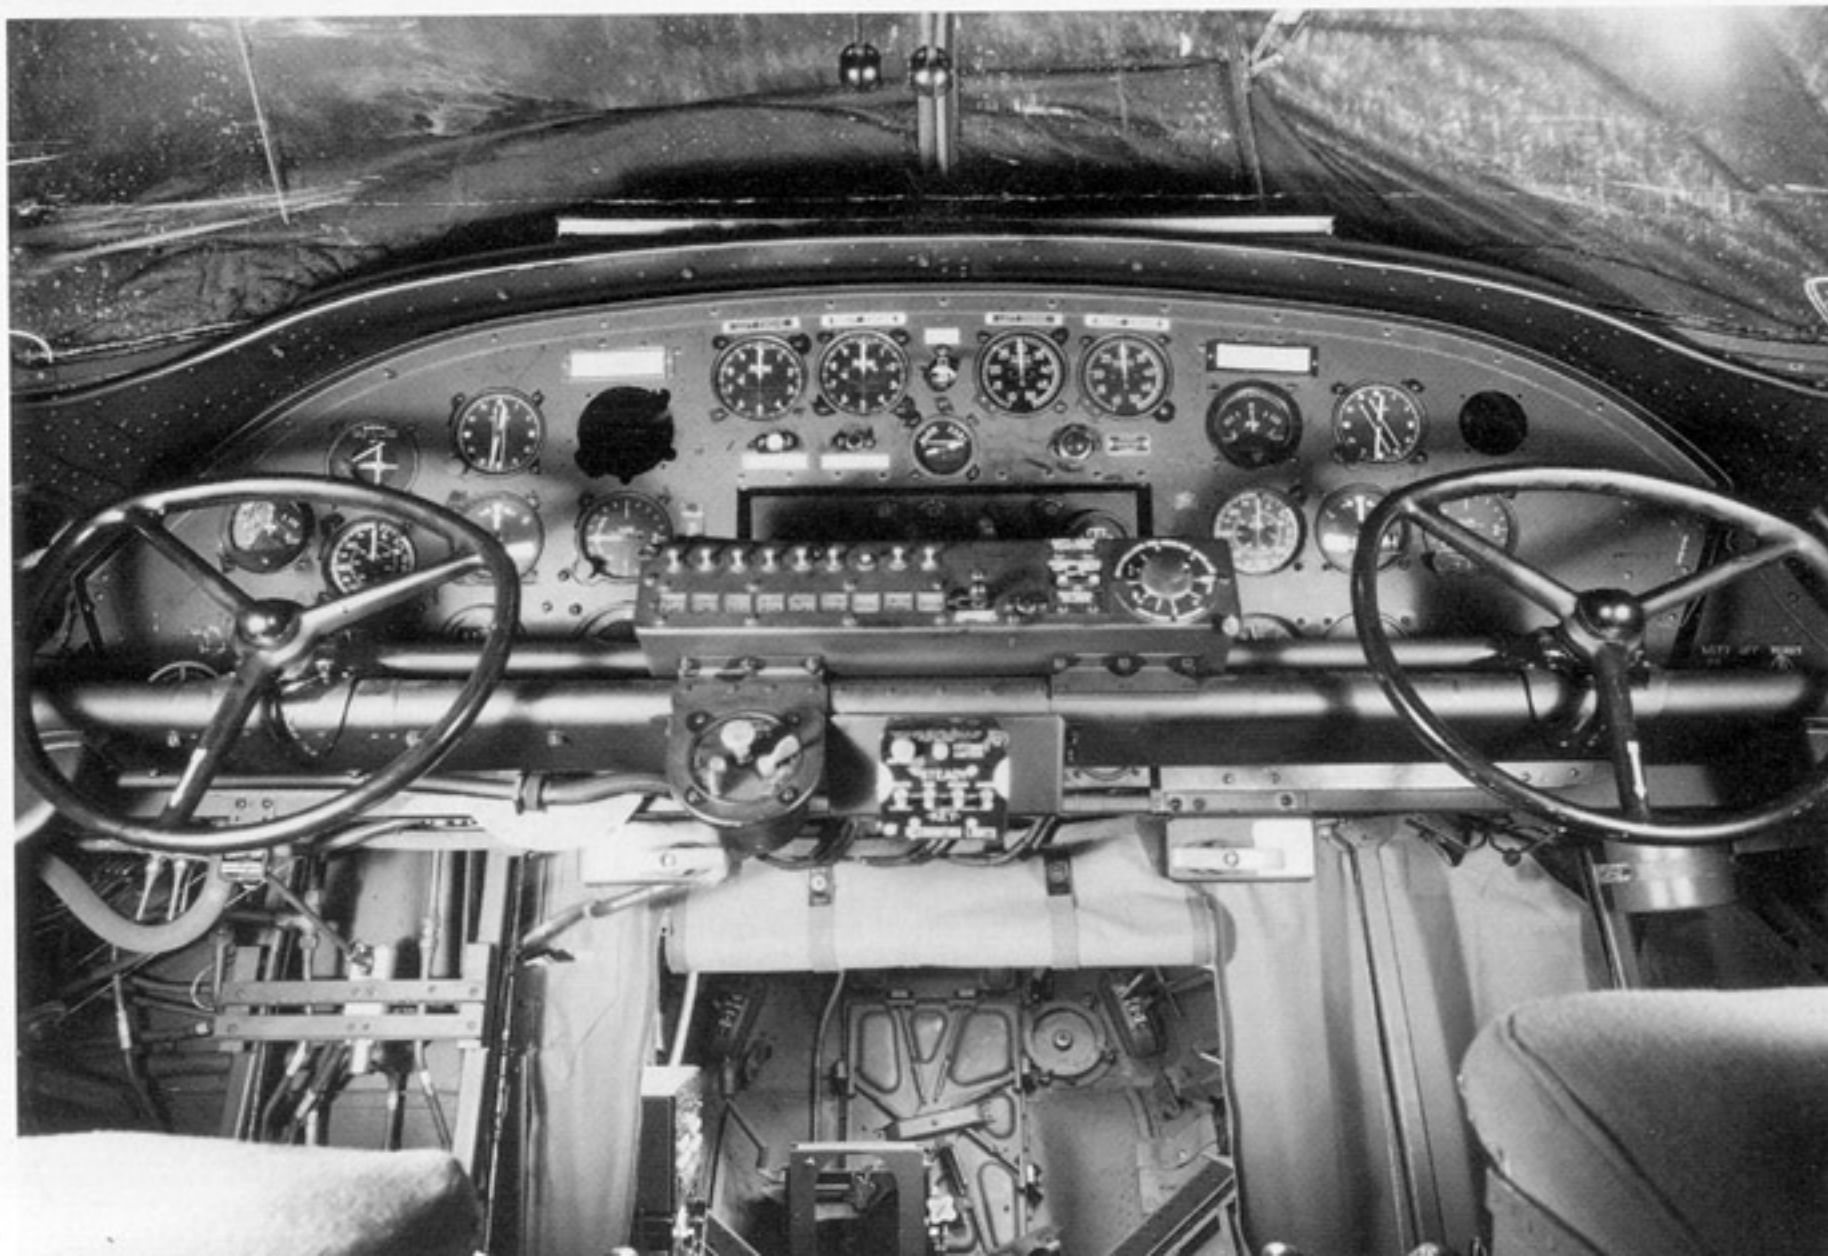
(Above) Looking forward into the cockpit of a PBY-5A. The pilot's rudder and brake pedals are at the bottom left, the pilot's control wheel is above, mounted on the cross cockpit yoke. On top of the yoke, was the signal system between the pilot's and mechanic. On the right end of the signal box are the controls for the deicing boots on the wing and tail. Under the yoke is the ignition switch for the engines and controls for wing-mounted recognition lights. Below the yoke and instrument panel are two "T" handles for manual salvo or emergency release of the wing rack bombs. Identifiable instruments visible on the left panel (from left, top row) Instrument Landing System, Gyro Compass, Clock. Middle row: Air Speed, Turn and Bank, Rate of Climb. Bottom row, Altimeter, Directional Gyro, Gyro Horizon. On center panel from left, top row, Tachometers, Manifold Pressure and Synchroscope indicator and on right, the Floats up warning Light. The Sperry Auto Pilot was behind the Signal Lights. Right panel top row: Radio Altimeter, Gyro Compass. Middle row: Blank, Turn and Bank, Rate of Climb. Bottom row: Altimeter and Air Speed indicators. Below the panel are the Copilot's Rudder and Brake Pedals. The cockpit was painted in Zinc Chromate Green with Black instrument panels, yoke and control wheels. (USN)

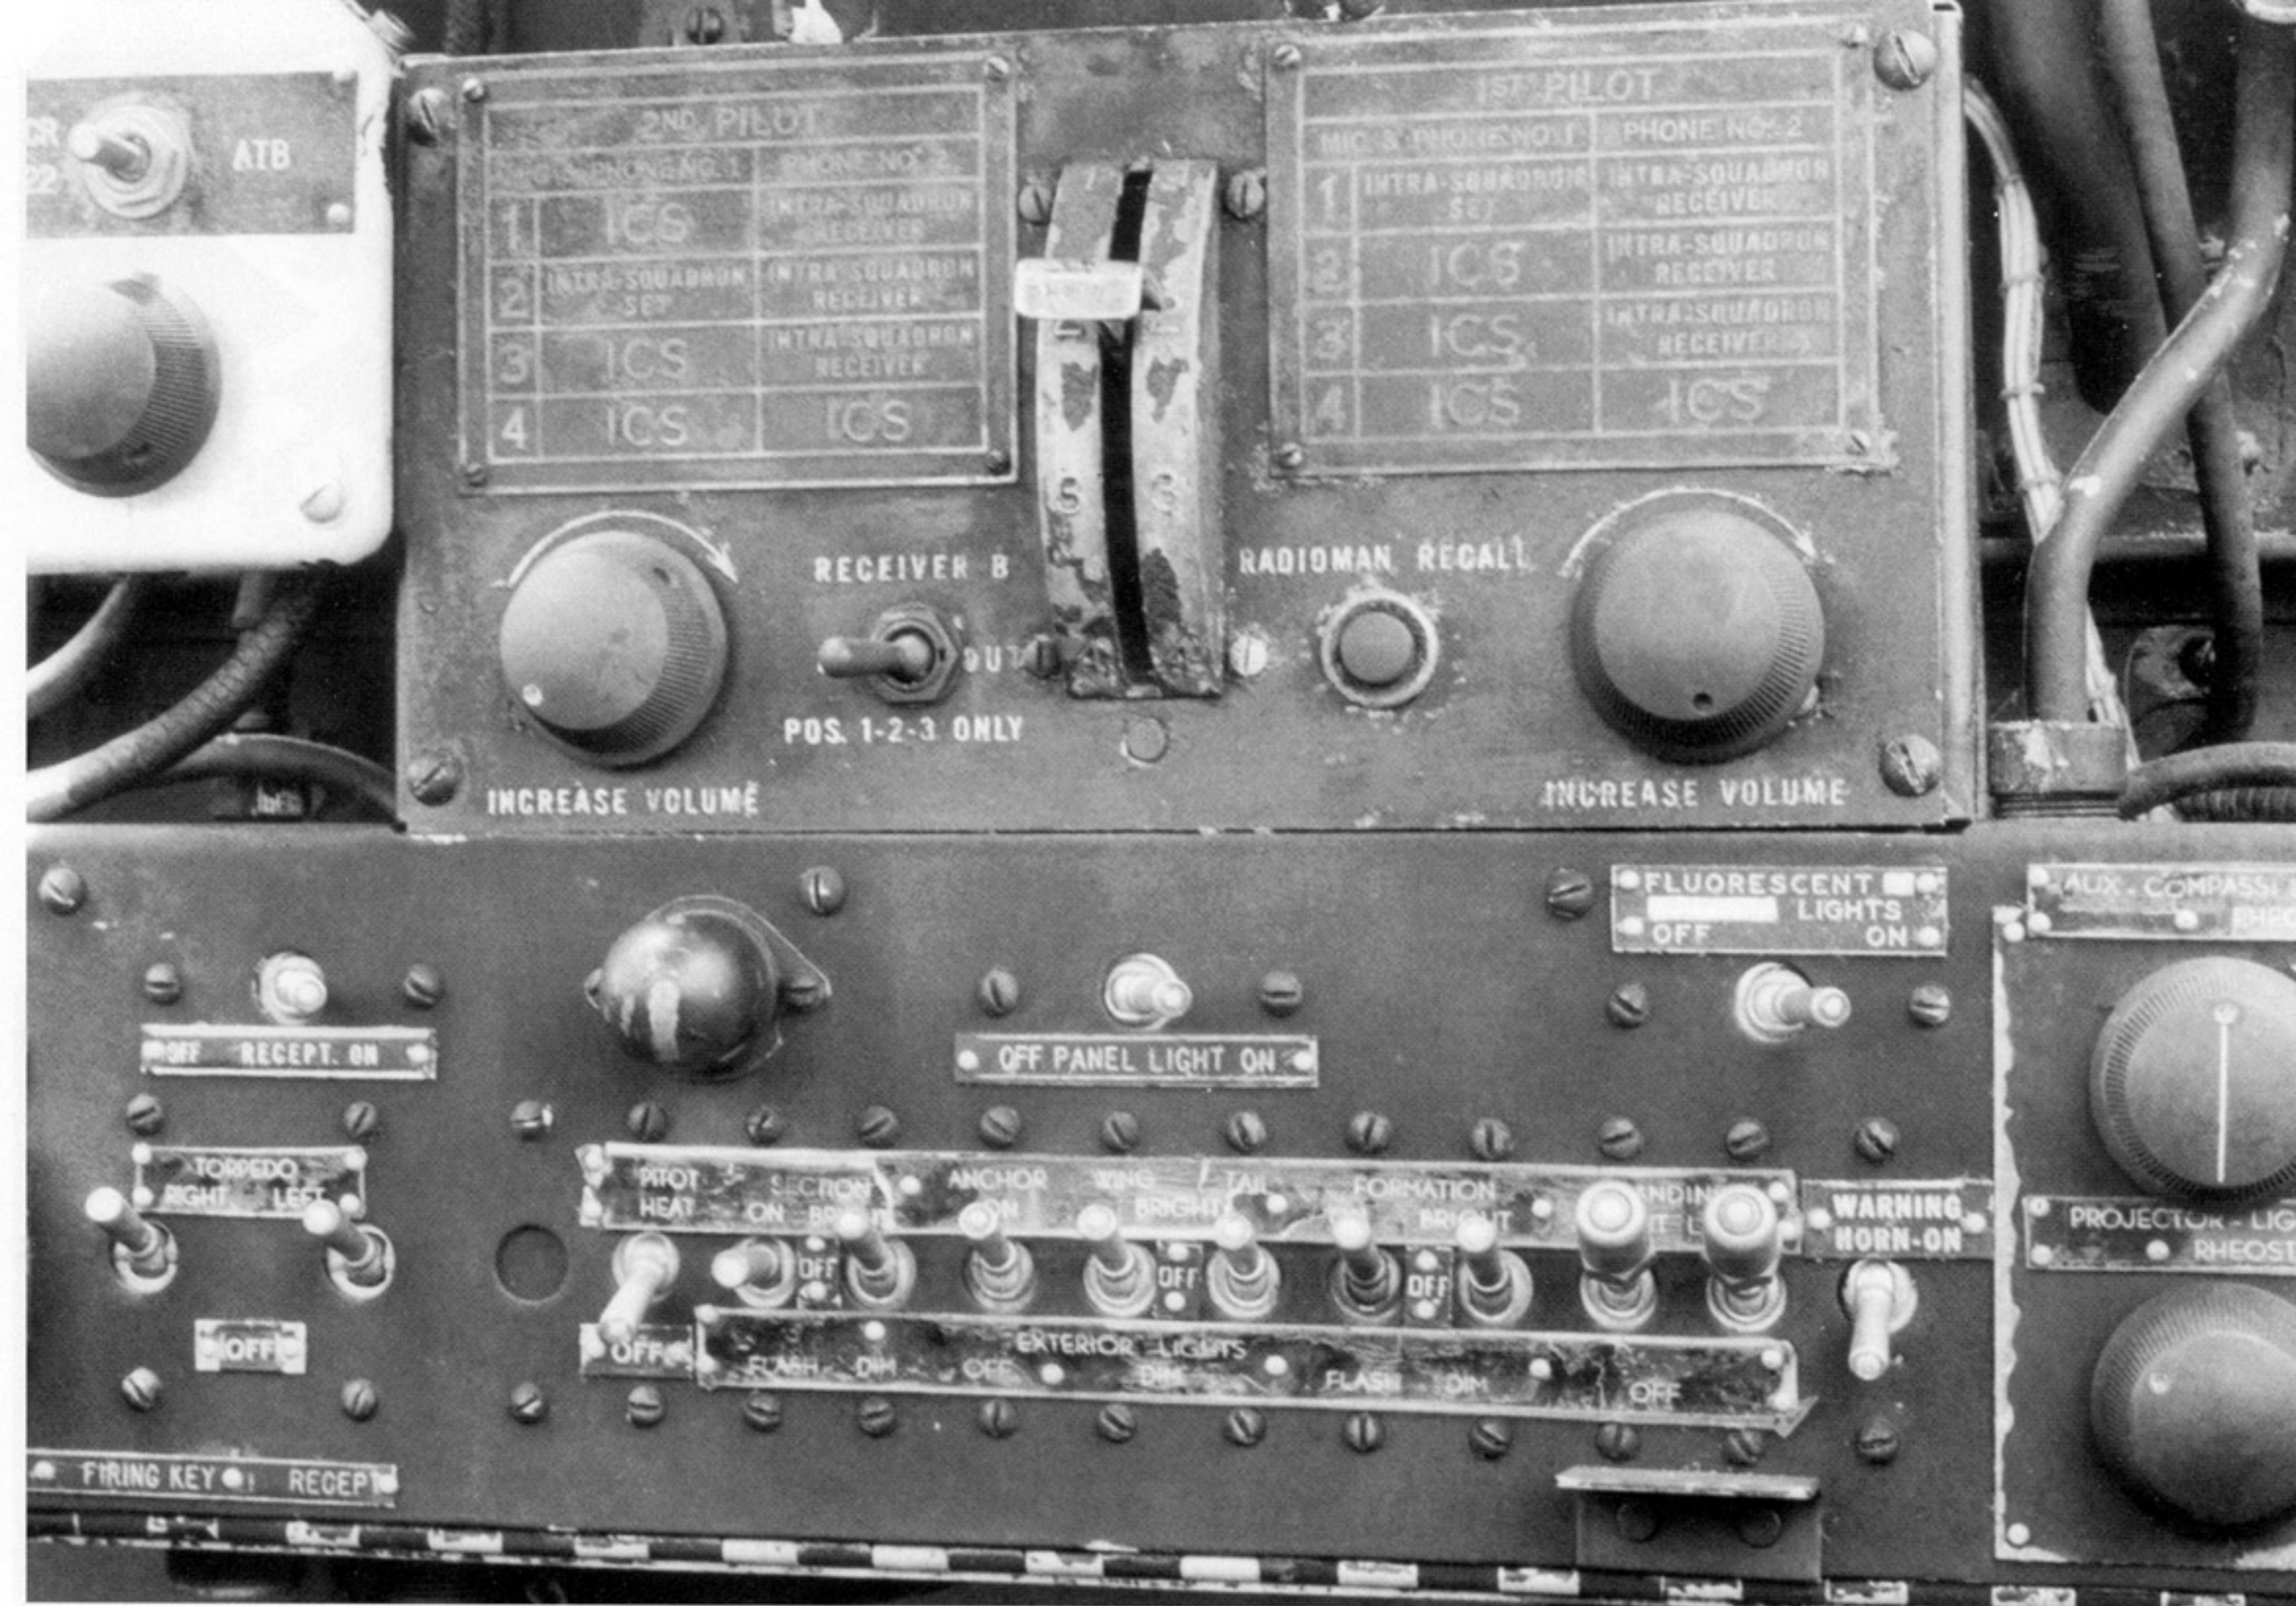
The panel installed at the top of the bulkhead behind the pilot's seat contained the controls for Intercom and Radio, on the top panel and the lighting controls (interior and exterior) on the lower panel. The receptacle for the remote "Pickle Switch" for bomb and torpedo release was located to the left of the lighting panel. (Author)

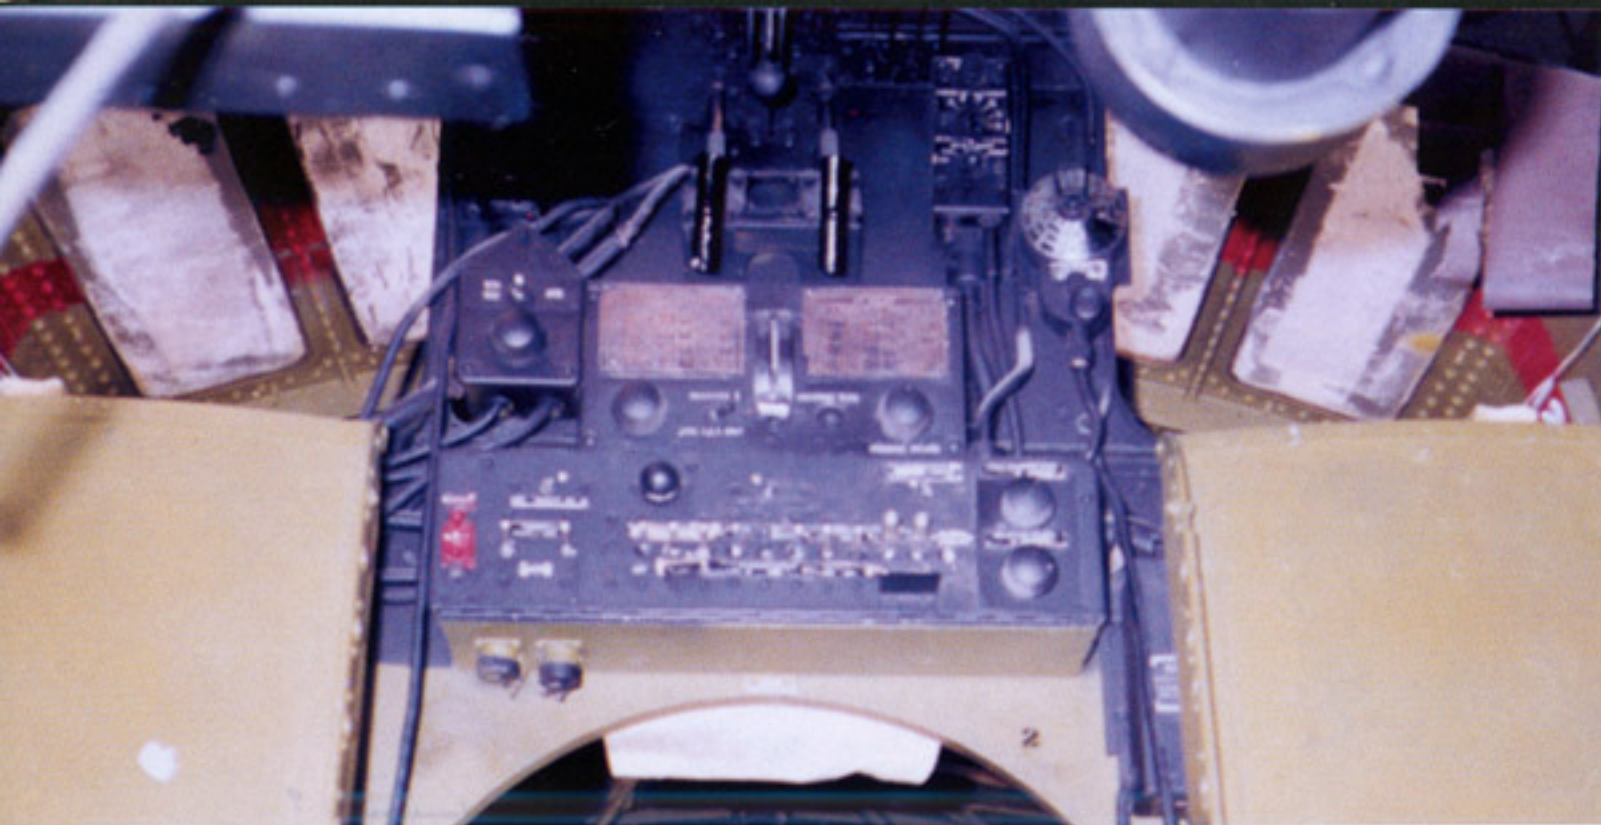
This is the bulkhead behind the pilot seats. The Black panel on the bulkhead has, from top down, two Black "T" handles which are pulled to release parachute flares from flare tubes in the tunnel compartment. Tuning control on the right side of the panel is for voice and radio range receiver, used for navigation and instrument flight. Toggles and knobs on the lower panel are radio controls. Placards in center of the panel identify combinations of radio receivers and intercom for each pilot. (Mooney)
